USDA FOREST SERVICE  
RESEARCH PAPER INT-97  
1971

# INVESTIGATION OF SLOPE FAILURES IN THE IDAHO BATHOLITH

M. J. Gonsior and R. B. Gardner

INTERMOUNTAIN FOREST AND RANGE EXPERIMENT STATION  
Ogden, Utah 84401

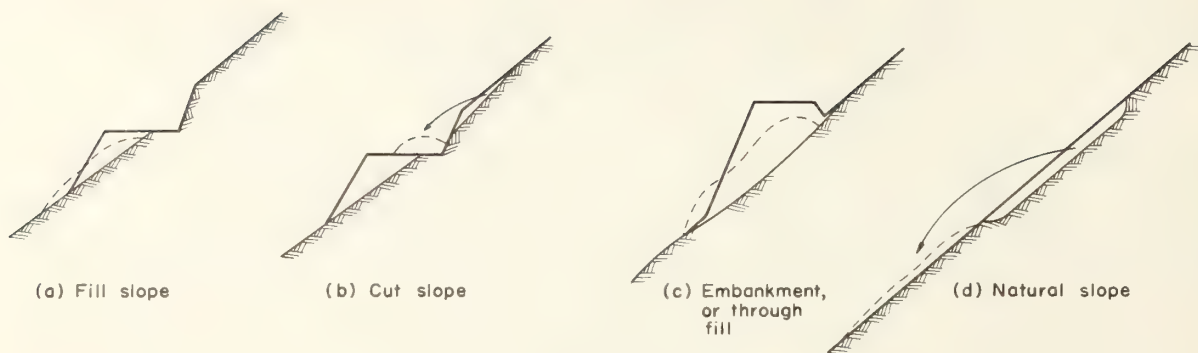
Figure 5.--Failure types.

A preliminary reconnaissance of the Zena Creek study area was made in May of 1967 to identify the extent and types of failures that occurred during the previously discussed 1965 storm event. As a convenience for analysis and discussion, four general failure types were identified, as shown in figure 5.

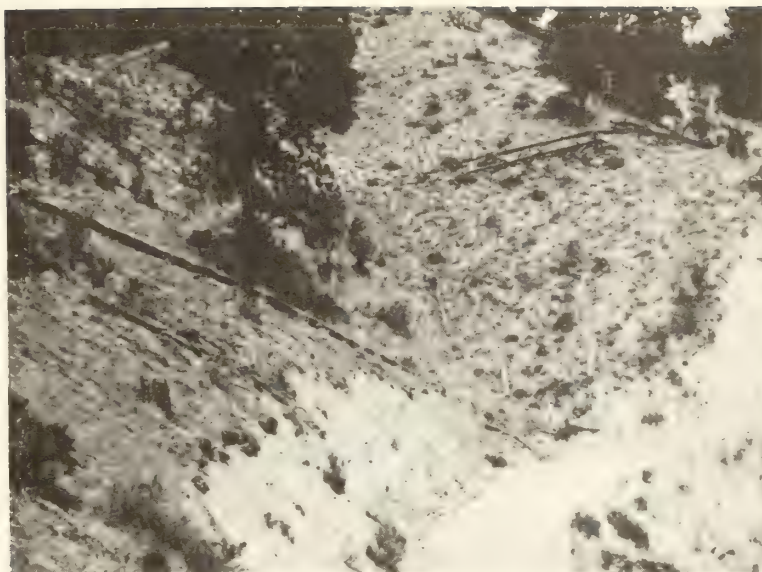
*Figure 13.--This illustrates proximity of site 917-1 to ridgetop.*

*Site 917-1.* As shown in figures 13 and 14, this site is a stable embankment crossing a small gully on Road 917 and is located approximately 1.7 miles from the junction of Road 917 and the main Secesh Road (fig. 4). A plan view and three profiles are shown in figure 15.

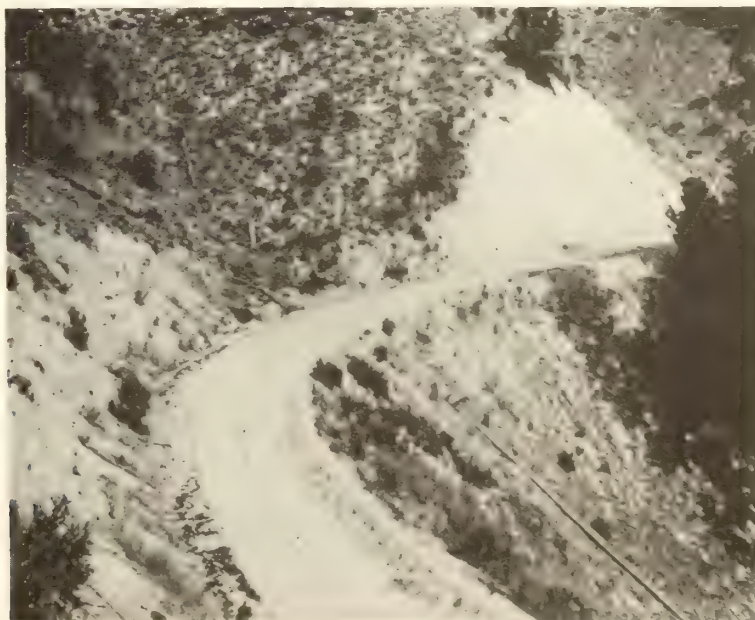
Provisions for surface drainage seem to be adequate at this site. A culvert has been properly installed in the embankment with a suitable downspout and wire mesh catchment to dissipate the hydraulic energy. The close proximity of the site to a ridgetop can be seen in figure 13, illustrating the relatively small drainage area contributing to the culvert flow. The road has a 9 percent favorable grade at this location and a similar embankment with drainage equally well provided for is located only about 100 yards up the road (east) from this site. Therefore, surface water flowing down the road does not present a drainage problem at site 917-1. A soil-cement berm, which can be seen in figure 14, prevents road-surface water from eroding the outside slope of the embankment.

*Figure 14.--This illustrates berm and culvert downspouts for proper handling of water at site 917-1.*

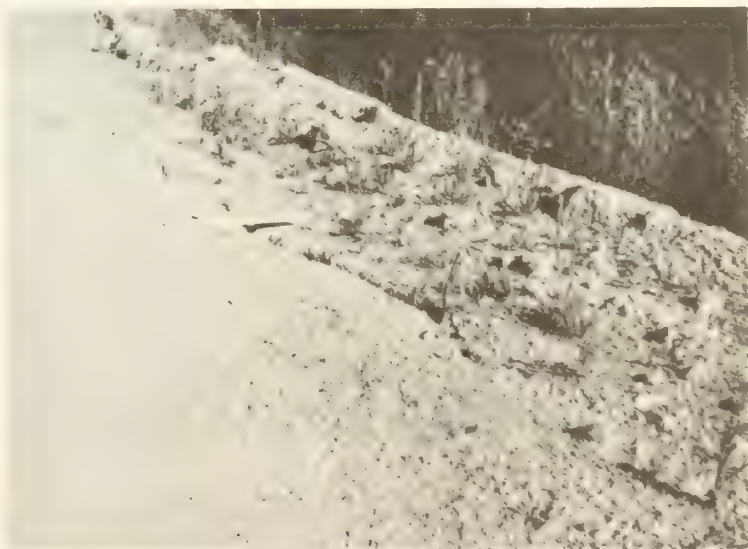
Figure 21.--Evidence of incipient failure at site 917-3, cracking and settlement of fill.

*Site 917-3.* This site, shown in figures 21-23, is located on Road 917 approximately 4.2 miles from the junction of Road 917 and the main Secesh Road (fig. 4). Considerable importance is placed upon the analysis of this site, primarily because failure is impending, as evidenced by cracking in the road surface and settlement of the outside portion of part of the fill (figs. 21 and 22). In addition, a narrow portion of the fill has failed, as shown in figure 23. Thus, this site offered the best opportunity for material sampling and definition of the mode and shape of failure.

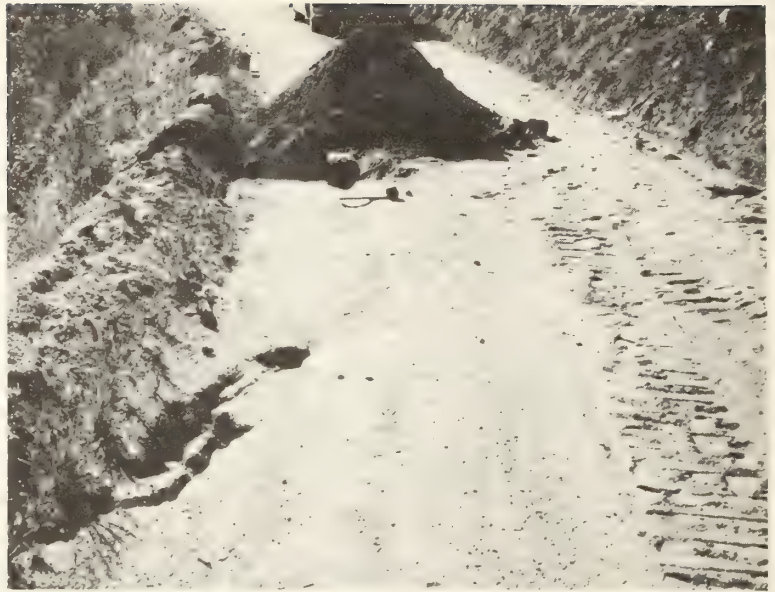
*Figure 22.--Additional evidence of incipient failure, site 917-3 (test pit excavation shown in top of photo).*

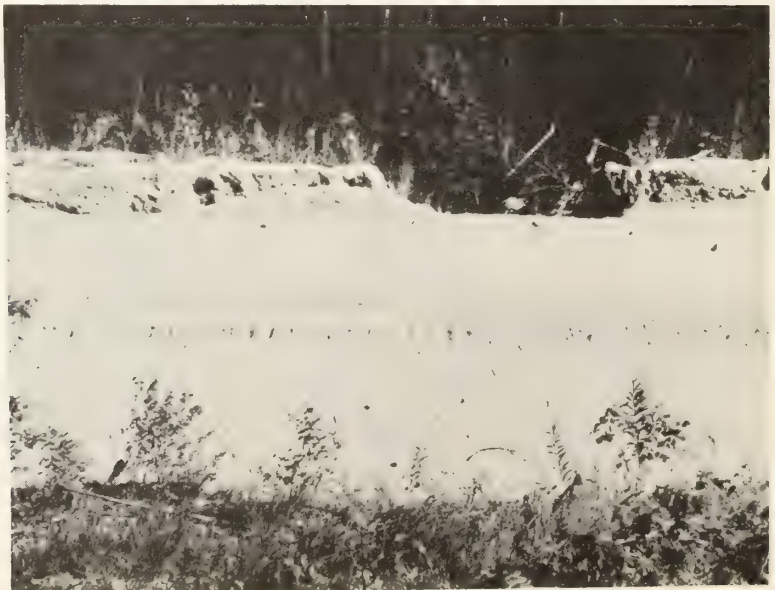
*Figure 23.--Narrow failure on fill at site 917-3.*

The low depth-to-length ratio of the failure at this site suggests that the infinite slope stability theory might be applied. Assuming a depth no greater than one-twentieth the length, or about 3.5 feet, developed cohesion values of only 0.18 and 0.03 p.s.i. are necessary for stability in the absence of seepage forces, for  $\phi = 35^\circ$

and  $38^\circ$ , respectively. Under the extreme condition that would permit seepage throughout the fill, with a top flow line coincident with the fill slope, the necessary developed cohesion values would be 0.83 and 0.75 p.s.i. for  $\phi = 35^\circ$  and  $38^\circ$ , respectively. Such an extreme seepage condition seems unlikely at this site, although it has already been noted that water collected on the road at this location. It is possible, however, that water infiltrating from the road surface combined with the ground water, resulting in emergence of the water at some location above and near the toe of the fill slope. A subsequent "blow out," or quick condition might have occurred locally, and the resultant loss of support at the toe would have allowed the upslope material to slide.

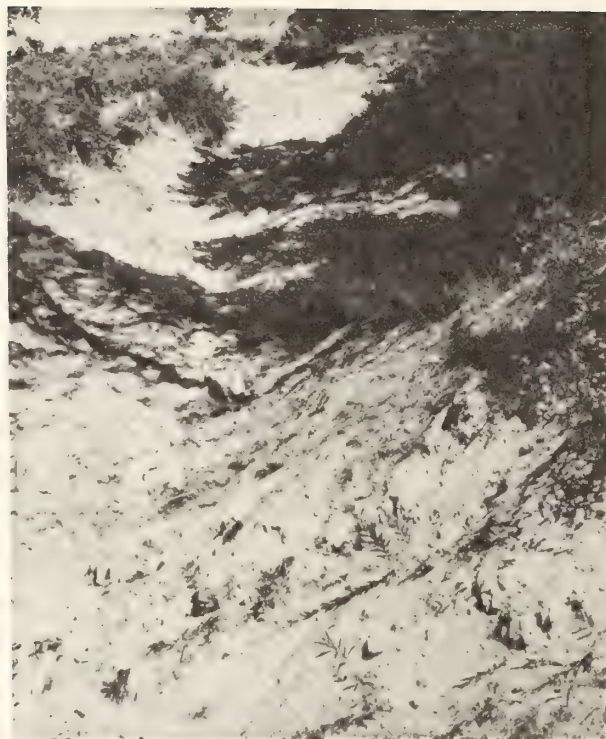
*Site 917H-3.* This site is a relatively long, narrow failure of material lying in a swale above Road 917H at a location within 100 yards of site 917H-2. It is pictured in figures 26 and 27, as viewed from the bottom and top of the failure, respectively.

Figure 26.--View from below site 917H-3, illustrating its long, narrow, and shallow characteristics.

Although the road cut intersected the bottom of the swale, it is difficult to state with certainty that this resulted in sufficient loss of support to cause failure. By using appropriate techniques for the analysis of stability of a cohesive, infinite slope, it is apparent that the natural slope might have failed in the absence of road construction. Such an analysis follows:

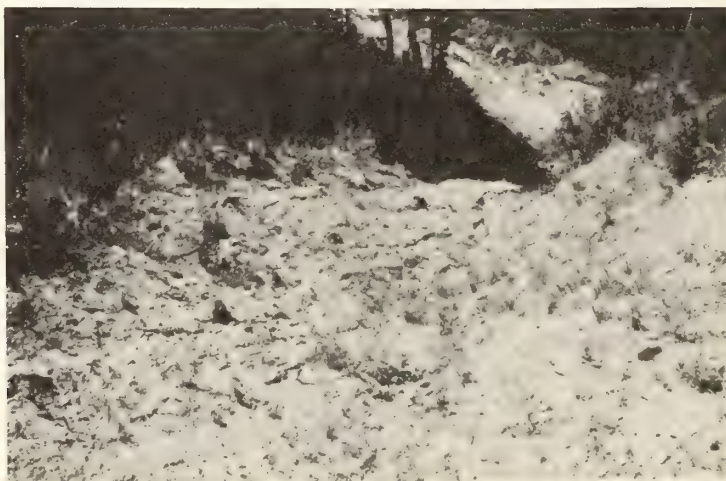
Figure 27.--View from above site 917H-3, illustrating road at bottom.
